AIRCRAFT ACCIDENT REPORT

IN-FLIGHT FIRE/EMERGENCY LANDING
FEDERAL EXPRESS FLIGHT 1406
DOUGLAS DC-10-10, N68055
NEWBURGH, NEW YORK
SEPTEMBER 5, 1996

**Adopted: July 22, 1998
Notation 6800B**

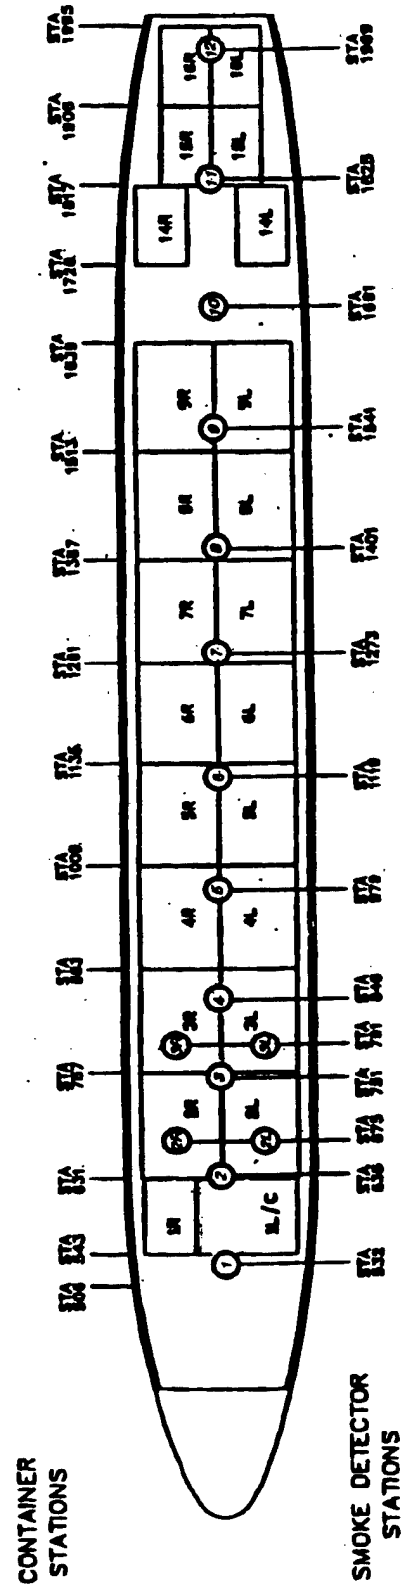
Figure 1.—DC-10-10, N68055, upper cabin cargo container positions and smoke detector locations.

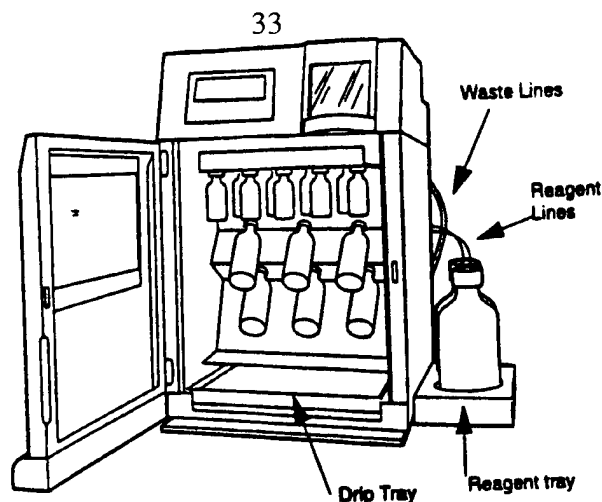
The Expedite Model 8909 DNA synthesizer was found in the center of container 6R lying on its left side with the top facing forward (as viewed from aft looking forward), the front towards the right side of the airplane, and the bottom facing aft (see figure 8 for a diagram of the synthesizer). The unit contained several bottles with labels that included flammability symbols, and some of the bottles contained liquid. One large bottle in the aft row had a very strong odor when it was removed from the unit. Because this unit was found at the lowest point of the "V" burn pattern, the Safety Board investigation evaluated and analyzed the liquids contained in this unit.

Figure 8.—Expedite Model 8909 DNA synthesizer instrument cabinet.
